DIFFERENT STRUCTURAL MONITORING TECHNIQUES IN LARGE RC BUILDING: A CASE STUDY

The main objective of this research is the retrofit study made in a large RC building after the structural intervention to correct same pathologies found. To do so, the new building of the Institute of Arts at the University of Campinas was studied. Vertical displacement of slabs and supporting beams was measured in specific points with auxiliary of dial gauges and topography as the load was applied in increments.

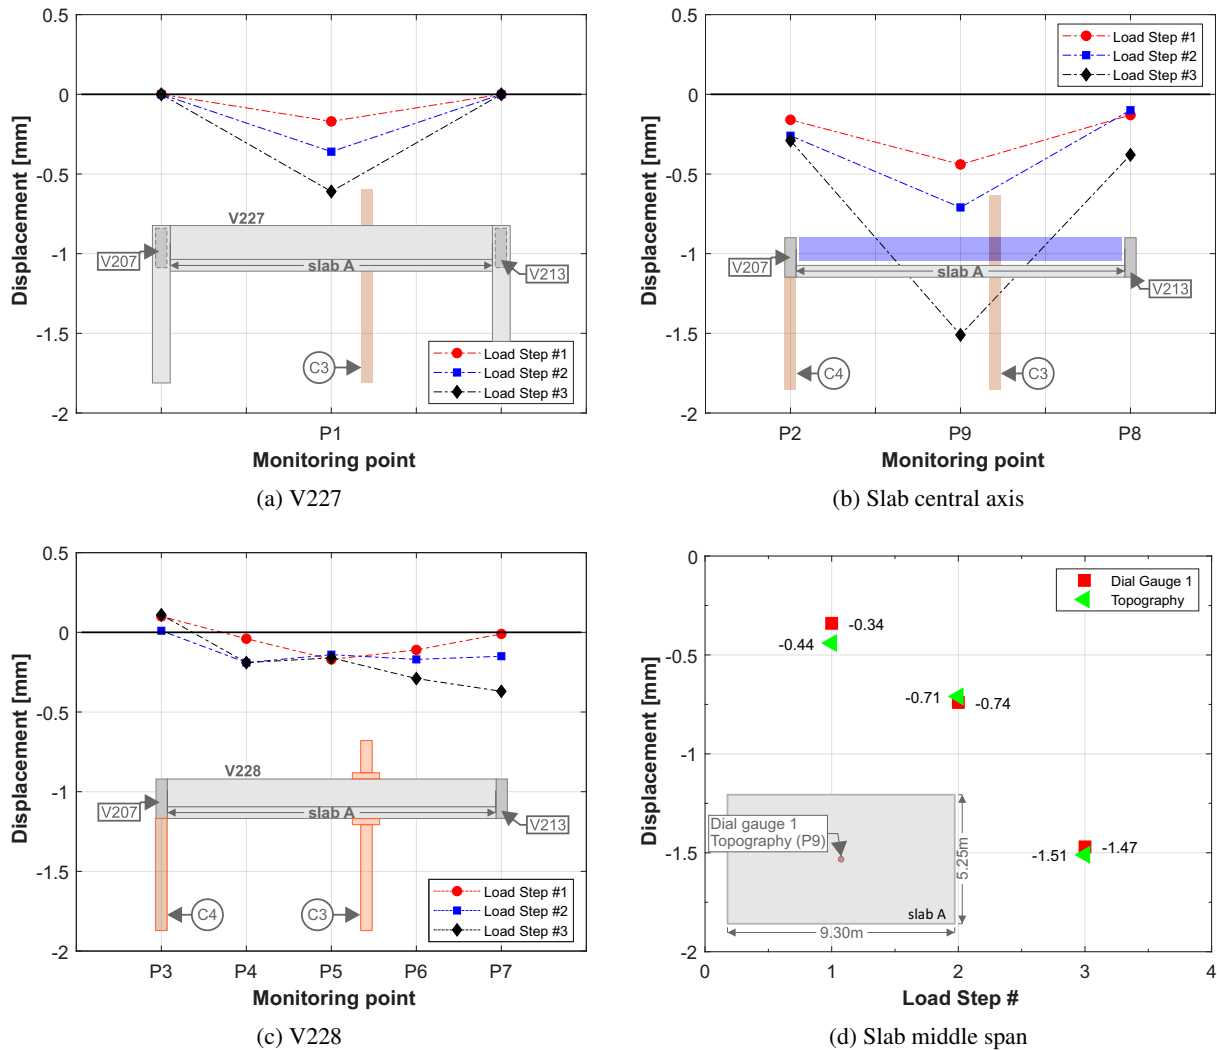
Figure 5. Measured displacements in the 1st floor load test.

The V227 beam axis is supported by two circular concrete columns with high flexural and normal stiffness (see Figure 5a). Therefore, it is reasonable to conclude that these two points did not move throughout the load test. The middle span presented the major displacement ($P1$) achieving -0.61mm .

Similar behavior occurred in the central axis represented by the monitors $P2$, $P8$ and $P9$ (see Figure 5b). In this case, the beams supporting the slab are less rigid than columns, as result both edges moves downwards. The support condition affected the water distribution given that the levelling difference from load step 1 to 2 was positive and negative for monitors $P2$ and $P8$, respectively. Also, the displacement magnitude when comparing load steps 2 and 3 was bigger on monitor $P8$ than on $P2$. This happens because in the left side the beam V207 is simply supported in two columns; while on the right side V213 is simply supported in one column and another beam. The maximum deflection of the middle span ($P9$) was -1.51mm .

At the edge of the tested slab A, the V228 beam axis is supported by two columns ($C3$ and $C4$) and one transversal beam (V213). Figure 5c illustrates the displacement pattern of this case. The influence of columns $C3$, $C4$, and the lack of direct support on the right portion became clear observing the deflected shape of V228 beam. Since the column $C3$ imposed a restriction, the vertical displacement at this position is admitted null. Initially, when small load was applied (step 1), the V228 axis behaved as a continuous beam with structural settling. The monitor $P5$ was dislocated from column $C3$, hence it had its displacement reduced. The 0.10mm lifting observed in $Pt3$ was not relevant and it is contained in the precision geometric levelling error.

As the load test continued (step 2), monitor $P3$ and $P5$ was practically held still while the others moved downwards. It was noted in load step 3 that the right portion of V228 beam axis experienced the major displacement. Also, no change was observed on the left span whereas the right portion moved. This could be caused by original crack condition of V228 beam preventing stress redistribution to the left portion. Monitor $P7$ reached -0.37mm deflection.

Point $P9$ was used to evaluate displacement at the slab middle span. Figure 5d shows the values obtained using the topographic equipment and the dial gauge 1. Overall, the results converged showing good agreement in the load steps. The relative difference between both monitoring techniques was below 0.1mm , which is the admissible error of the equipment.

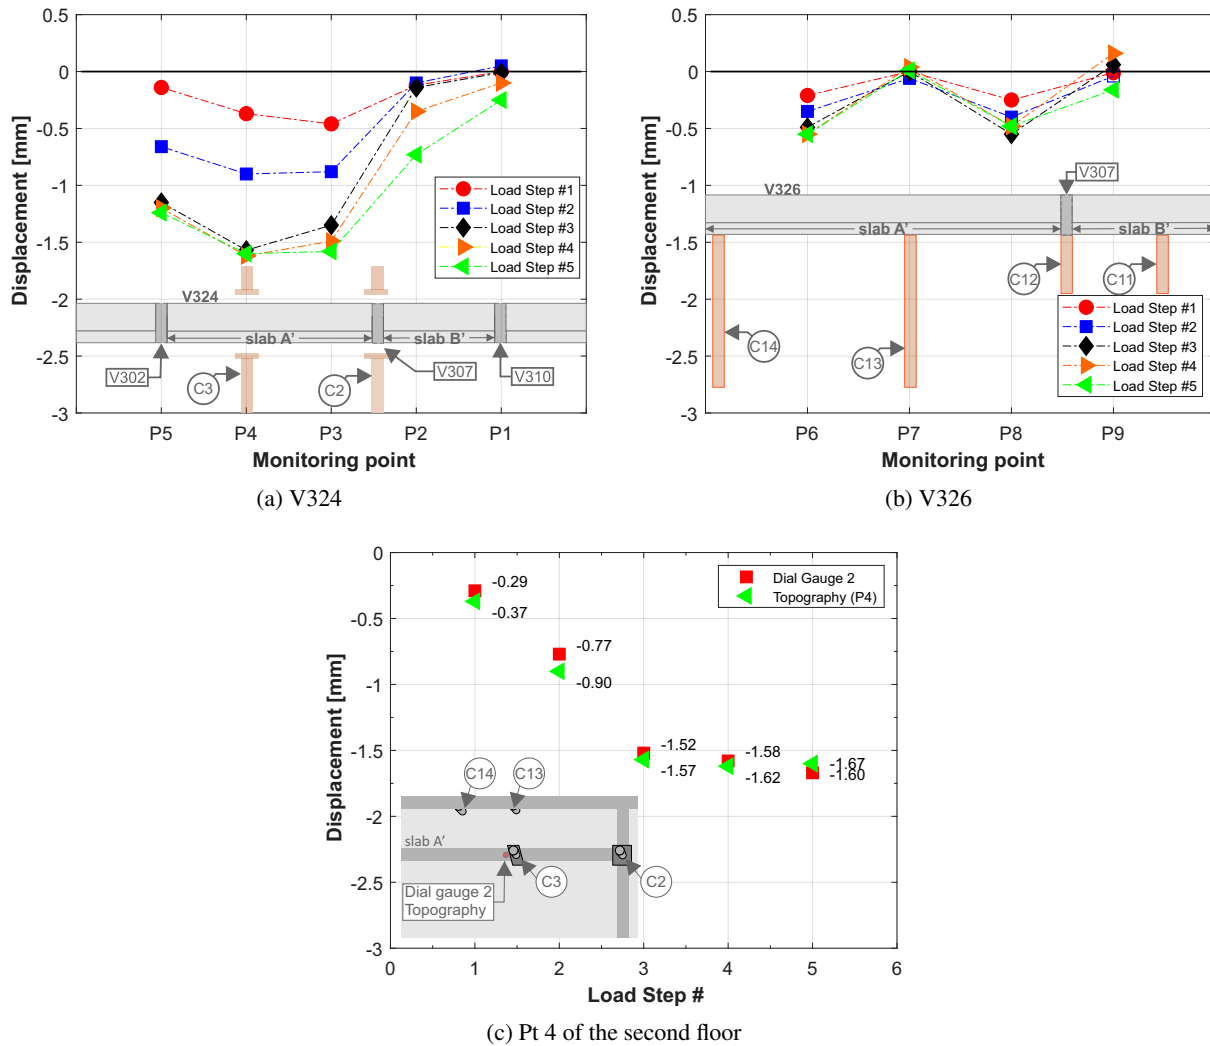
Figure 6. Measured displacements in the 2nd floor load test.

In the internal line axis (see Figure 6a) there are beams supporting slab A' and B'. Therefore, no monitor were kept in the original level and all monitors moved downwards. As the slab A' was being loaded in steps 1 to 3, the monitors P1 and P2 remained practically immovable indicating that this process did not affect the slab B'. However, the displacement magnitude on the monitors P3 to P5 increased. When the slab A' was filled and the load started being applied on slab B' (steps 4 and 5), the displacement magnitude of the monitors P1 and P2 increased whereas in others it didn't happened. This indicates that loading slab B' did not have significant influence on slab A'. The major monitor displacement (-1.60mm) happened in P4 which is near to the midspan of slab A'.

The external line axis is simply supported by four columns in the slabs A' and B' region (see Figure 6b). It was observed on monitor P6 and P8, located at midspan of slab A', that the displacement enhanced throughout the three first load steps. The last two load steps were applied to the slab B' whilst slab A' had filled, thus its influence was not significant on monitors of slab A'. As expected, displacements of monitor P7 located above column C13 can be neglected.

Monitor *P9* experienced a minor lifting at the initial load steps. There are two possible explanations for this effect being the first one related to equipment error involved. The second could be explained by a leverage effect that happened when monitor *P8* moved down and column *C12* remained fixed. By the end of the load test, when both slabs were filled in step 5, the structure settled and the monitor *P9* moved down -0.16mm. The major displacement registered -1.60mm occurred on monitor *P4*.

An attempt was made to keep dial gauge 2 aligned with monitor *P4* positioned in the bottom face of *V324* beam. Figure 6c shows the displacement results using dial gauge and precision geometric levelling. It was noted good agreement in the measurements of all load steps. The major difference between both methods occurred on step 2 in which precision levelling absolute displacement was 0.13mm bigger than dial gauge reading. Looking at the last two load steps it become clear the effect of loading slab *B'* can be neglected on slab *A'*.

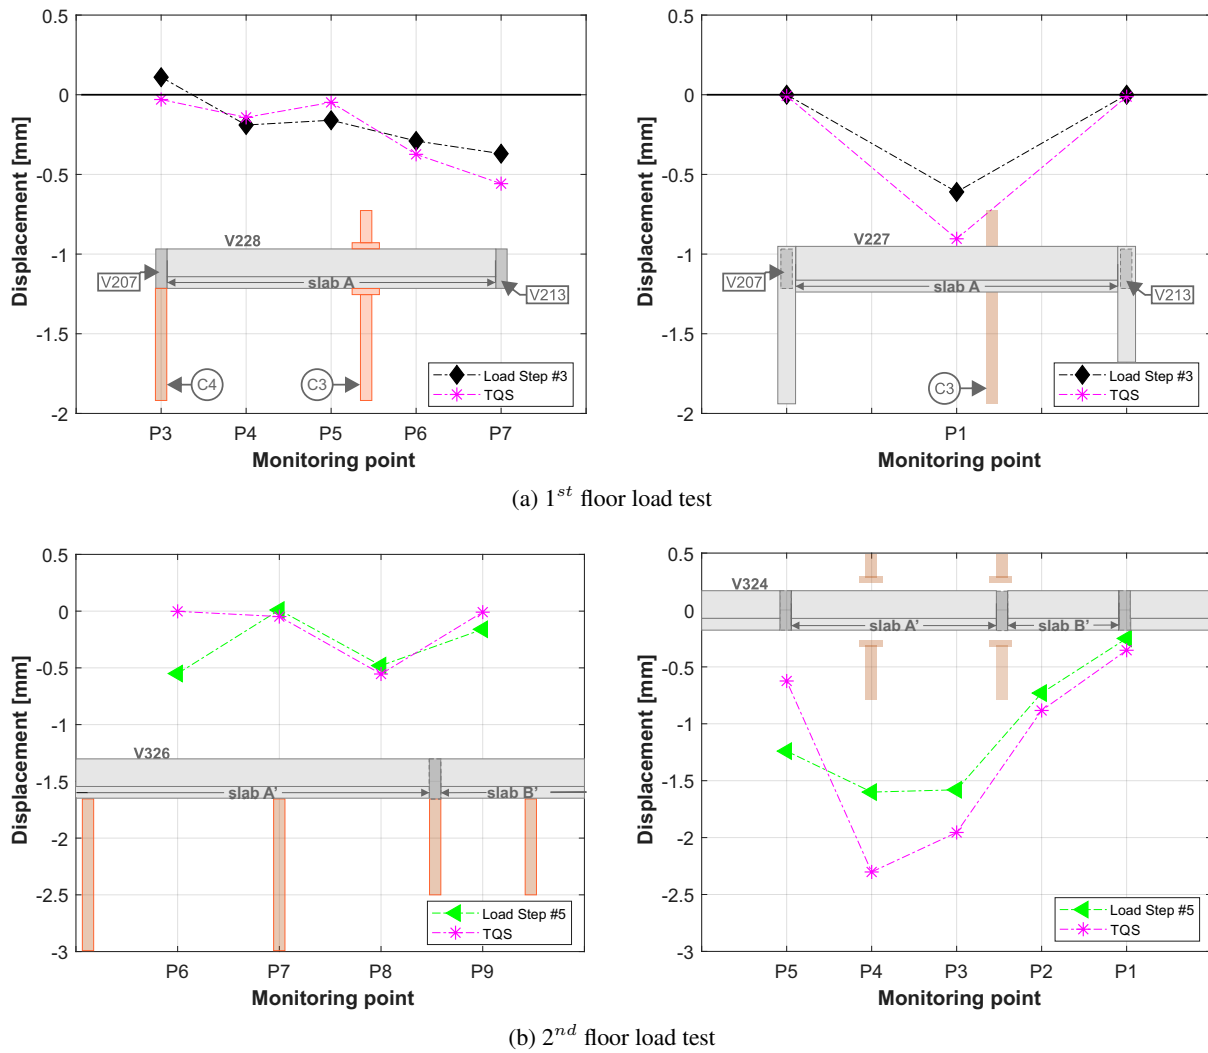
Figure 7. Comparative results with numerical model.

In general, the numerical analysis have shown more ductile behavior than the precision levelling. There were identified similar displacement patterns using both methods. However, the value difference between both methods are a tenth of millimeter which can be neglected when analyzing this structure.

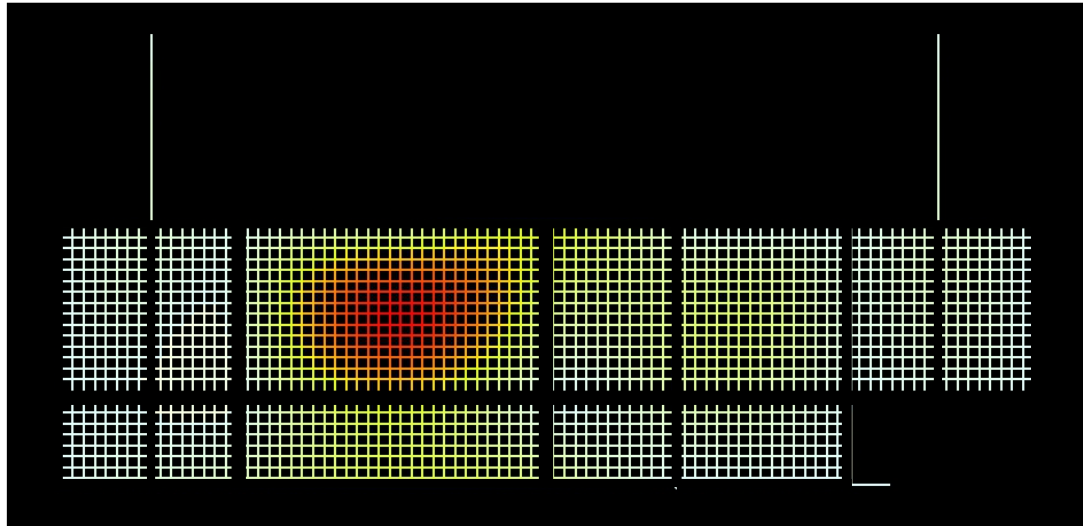
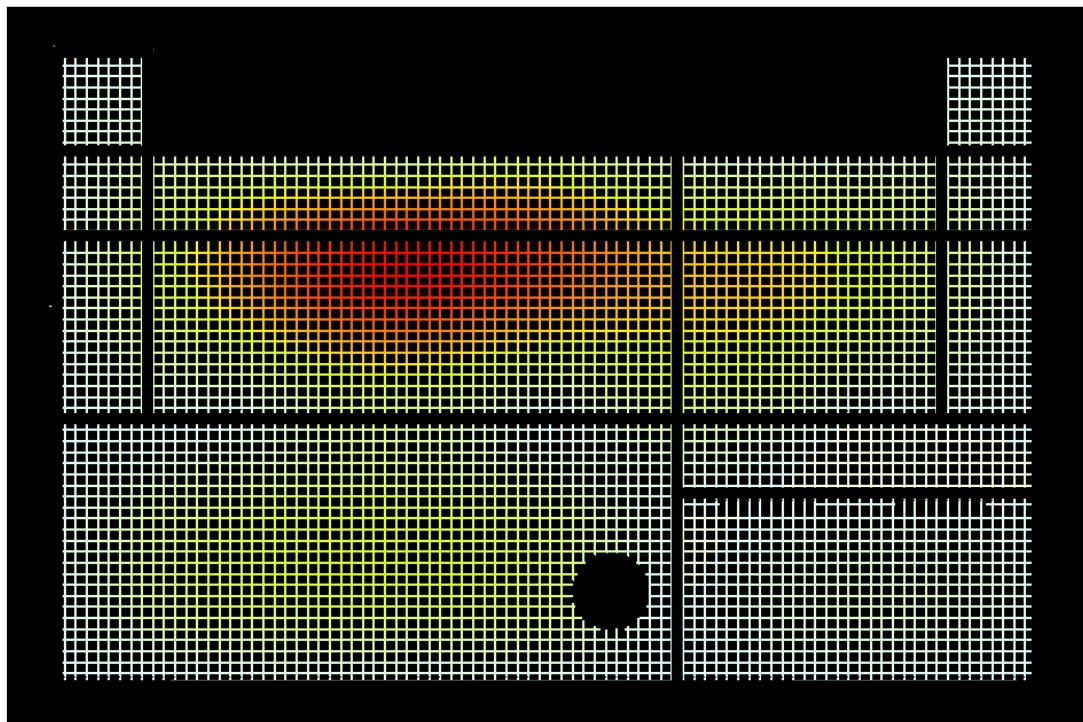
Figure 8. Displacement pattern obtained through non linear analysis of TQS programme.

In the experimental and numerical results, the displacements were way below the limit, probably due to the inclusion of new columns in the strengthening process. Additionally, the structural elements cross-section contributed for reducing the deflection, once they had higher stiffness. The slabs, for example, had 200mm thickness whereas some beams had 250x750mm section.

Figure 8 shows the final floor displacement obtained in the load tests. An attempt was made to simulate properly the boundary conditions of the pavement given that it is mostly supported by reinforced concrete walls. For this, the entire floor was modeled and the RC wall region was considered as a column with cross section equal the wall.
