# Buckling analysis of storage tanks based on the use of geometric imperfections measured by laser scan dimensional inspection techniques

**Abstract.** Storage tanks are thin-walled equipment often subjected to wind loadings, which may lead the equipment to structural instability. The critical buckling load of storage tanks are too sensitive to structural imperfections, that can be present at its structure taken into account damage mechanisms which tend to reduce the structural integrity of this type of equipment along its life cycle. Inspection techniques are employed to characterize damage mechanisms, which in turn are assessed to evaluate whether or whether not the equipment may have a safe operation. The laser scan technique has been shown to be accurate in dimensional inspection of storage tanks. This paper focuses on the structural integrity assessment of an actual damaged surface of a real storage tank. The tank is 43.428 m in diameter and 14.63 m in height and is used for diesel storage. Deformations are present at the structure of the tank, which are measured with an industrial laser scan. The point cloud resulting from the dimensional laser scan inspection is used to bui

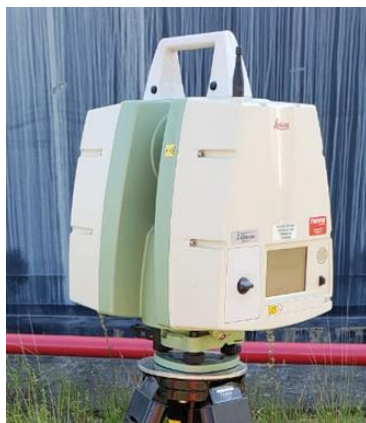
Figure 1. C10 model terrestrial laser scanner from Leica Geosystems

The shell distortions of the tank were measured by the C10 model of the Leica Geosystems Terrestrial Laser Scanner, shown in Fig. 1. The objective of this step was the 3D mapping of the shell to develop a finite element mesh more similar to the actual structure, accounting explicitly the geometric imperfections. The result of the dimensional inspection was a raw point cloud containing several unwanted scanned objects like structures, valves and piping systems, scaffolds and others. A cleaning process on the raw point cloud was required to remove the unwanted scanned objects for the posterior finite element analyses, for that, the Cyclone 9.0 software was used (see Fig. 2).

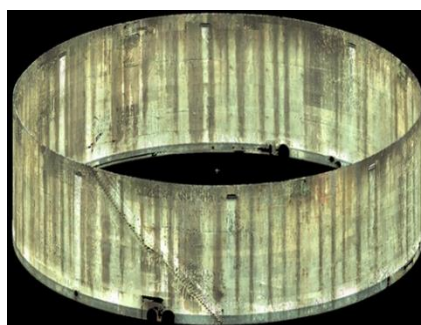
Figure 2. Cleaned point cloud

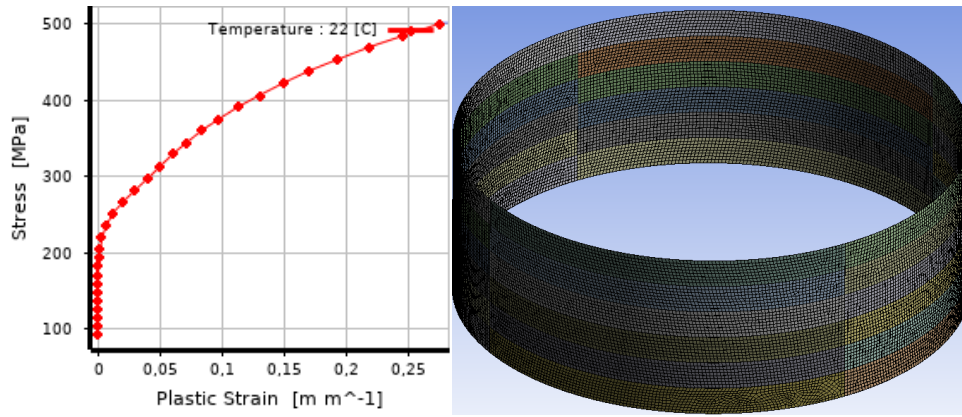
Figure 3. Cleaned point cloud

The equipment stores diesel oil. However, consider water for the hydrostatic pressure was a conservative hypothesis, because the density of water is higher than that of diesel and the tank can be used to store water. Loads from wind were applied at the shell in four different directions on the Cartesian plain (X,Y), with the guidelines from ABNT NBR 6123 [14] which parameters used are available in Tab. 2. The bottom of the first shell of the model was constrained and for the material nonlinearities an isotropic hardening plasticity constitutive model was utilized, considering a multilinear behavior (Fig. 3 left). A quadratic shell element (SHELL281 from ANSYS element library) with eight nodes and six degree of freedom per node was used for the meshing process, resulting in model with 66727 nodes and 21961 elements (Fig. 3 right). To obtain the deformed model mesh, a previous linear elastic analysis was performed with the radial distortions, from the sample point cloud, as load displacements. The deformed mesh was used to assess failure modes criteria from API 579 [4].

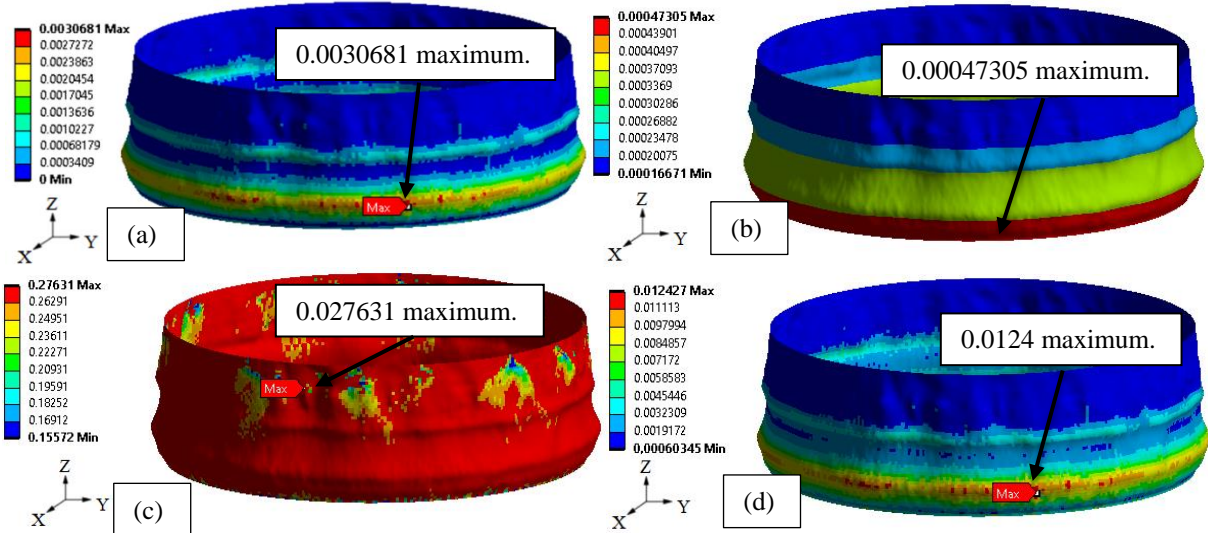
Figure 5. Equivalent plastic (a) and cold forming (b) strains; strain limit (c) and local failure criterion (Eq. 5) (d).

The protection against plastic collapse and local failure were assessed through elastic-plastic analyses. The criterion to evaluate plastic collapse was the nonlinear analysis convergence, considering load combination from Eq. 1, to guarantee the equipment protection. Strain analysis defined by Eq. 5 had to be satisfied (considering load combination from Eq. 2) for the local failure criterion, where  $\varepsilon_{peq}$ : Equivalent plastic strains;  $\varepsilon_{cf}$ : Cold forming strain of the steel plates (from ASME PCC-2 [15]); and  $\varepsilon_L$ : Plastic strain limit, given from Eq. 6.

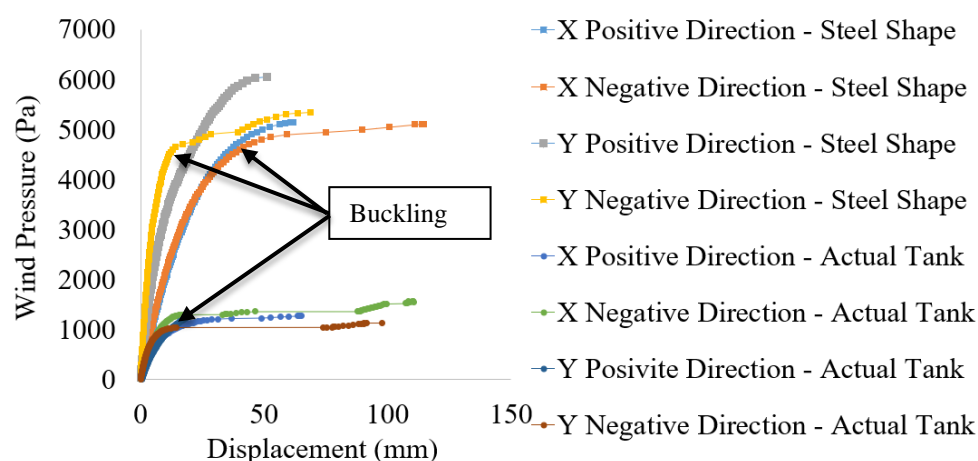
Figure 7. Wind pressure load versus displacement curves for the buckling analyses.

The actual tank shell buckling analysis results indicated structural instability for the 957.4 Pa (1531.84 Pa with 1.6 load factor) wind pressure. Structural steel shapes (see model in Fig. 6) on the actual deformed tank shell were simulated to evaluate the buckling resistance and the results indicated structural stability. Wind pressure versus displacement curves for each analysis is available in Fig. 7 and summary results in Tab. 3.

Wind direction	Shell condition	Critical buckling pressure (Pa)	Criterion
X axis positive	Actual	1275.3	Not met.
X axis negative	Actual	1571.1	Met
Y axis positive	Actual	1253.8	Not met.
Y axis negative	Actual	1126.9	Not met.
X axis positive	Steel Shapes	5141.6	Met
X axis negative	Steel Shapes	5113.1	Met
Y axis positive	Steel Shapes	6050.0	Met
Y axis negative	Steel Shapes	5335.0	Met
