# Remote inventory and inspection of the truss bridge elements and connections using STS and UAV

This paper presents an attempt to use a Scanning Total Station (STS) and photogrammetric documentation recorded with the use of an Unmanned Aerial Vehicle (UAV) for the inspection and inventory of the dimensions of a truss railway bridge over the Vistula River in Poland.

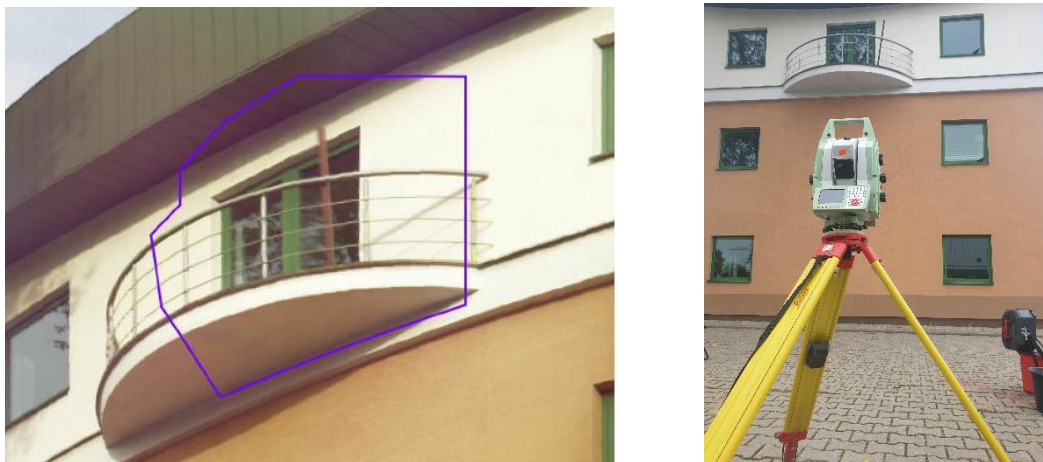
Figure 1. Laboratory tests; from the left: scan area as indicated on the display; from the right: Scanning Total Station during field survey.

Two laboratory tests were conducted to assess the accuracy of the measurement method in different environmental conditions. In both tests, the measured object was a steel bar on a balcony, as seen in Figure 1. This was performed to simulate the conditions that could be present at the bridge site — the vertical distance between the station and measured elements. The tests aimed to measure the dimensions of the beam using reflector-less measurements and point cloud scanning, and then compare the results with the known dimensions of the beam.

planes was calculated. This approach is only applicable to symmetrical objects with at least two parallel faces. Additionally, in both tests, laser scanning was done. The scan area of one of the scans can be seen in Figure 1. The STS can capture point clouds from several stations and combine them into one during surveying on the built-in software. This allows for on-site verification of obtained scans. Combined point clouds captured from at least two measuring stations were created. The point clouds were then used to obtain the dimensions of the beams in both tests.

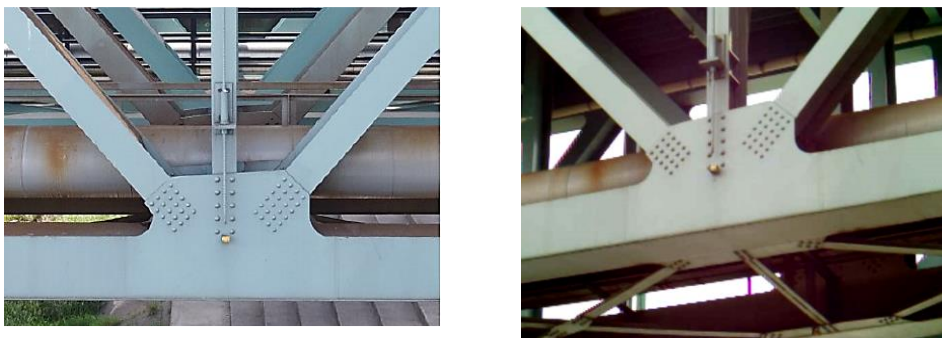
Figure 4. Photographs of the analyzed connection; from the left: taken from a UAV; from the right: taken from STS.

For the experiment, a main structural connection of the truss, shown in Figure 4, was chosen. It is a W-type asymmetrical connection, joining one vertical member and two diagonal members with the lower chord of the truss. The members are connected by a gusset plate and are joined using rivets. Each of the three riveted connections is unique in the number and position of the connectors. This connection was selected for Remote inventory and inspection using STS and UAV since it was designated as repaired in the post-renovation documentation. In addition, the location of the connection provided easy access to the measurements from the sidewalk under the bridge.

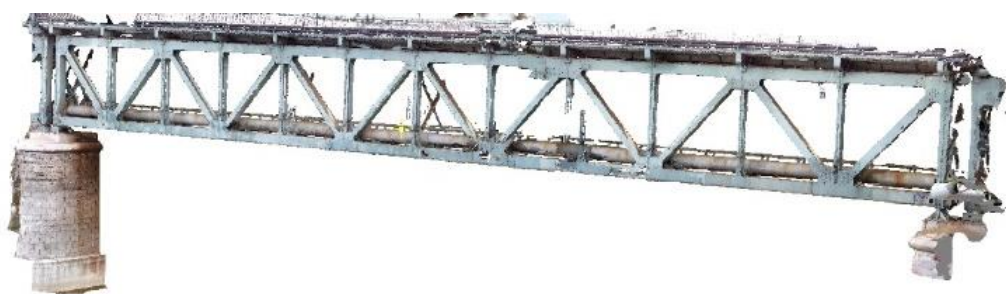
Figure 5. Façade of steel truss bridge

The UAV was used to acquire 646 images from the span studied for creating a point cloud using photogrammetry. The system allowed to reconstruct the façade of the steel truss bridge as depicted in Figure 5. The technique showed a few limitations related to an insufficient number of images of the area resulting in voids in the point cloud.
