DIFFERENT STRUCTURAL MONITORING TECHNIQUES IN LARGE RC BUILDING: A CASE STUDY

The main objective of this research is the retrofit study made in a large RC building after the structural intervention to correct same pathologies found. To do so, the new building of the Institute of Arts at the University of Campinas was studied. Vertical displacement of slabs and supporting beams was measured in specific points with auxiliary of dial gauges and topography as the load was applied in increments.

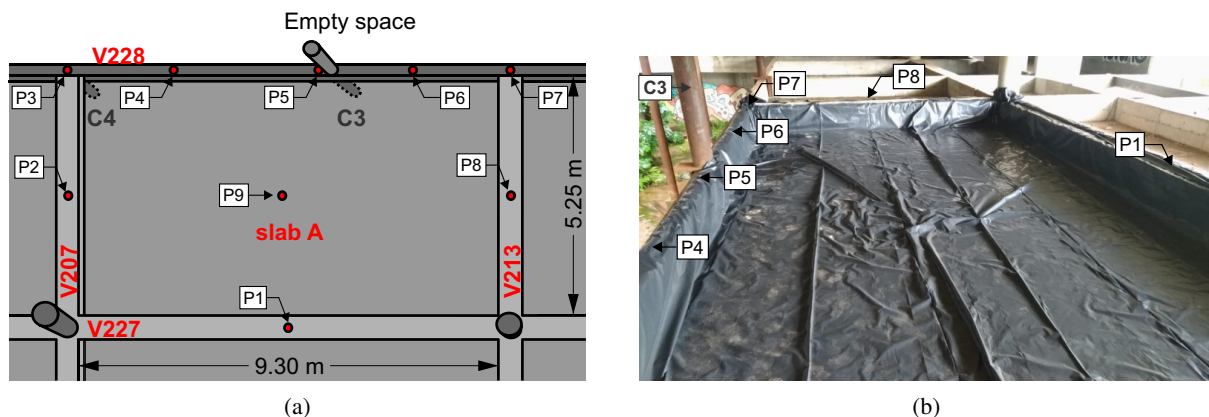
Taking advantage of the inverted beams shuttering, a thin sand layer was deposited to rectify the first floor slab and covered with plastic canvas (see Figure 1). Afterwards, the water was pumped in three intervals (load steps) until it reached 15cm, 30cm and 50cm depth and the displacement read at the end of each one.

Figure 1. Monitoring points in the first floor slab.

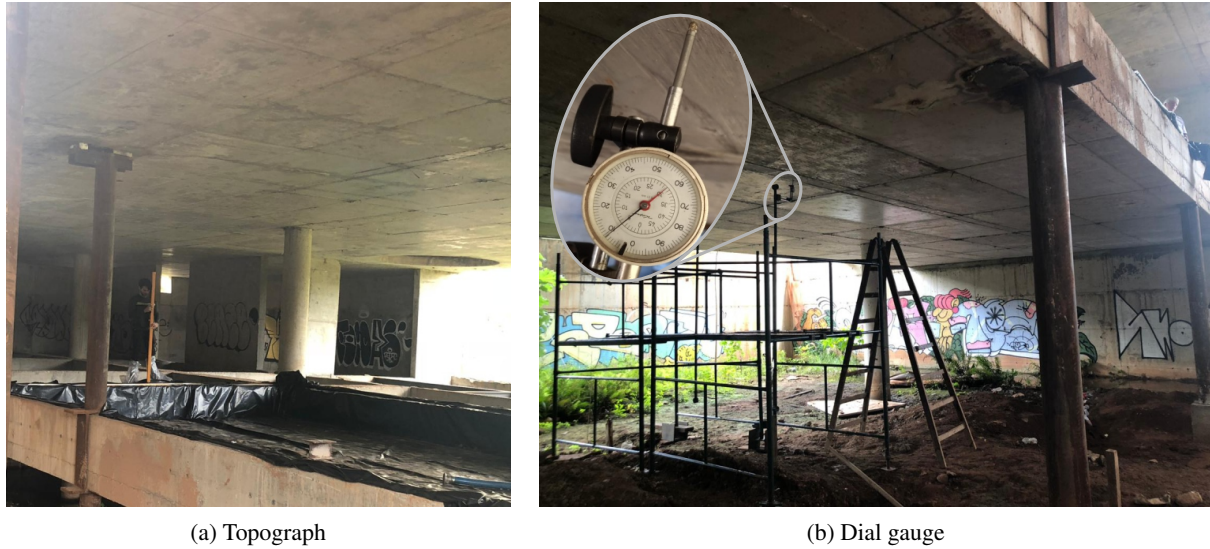
The dial gauge 1, which evaluated displacement on the first floor, was located in the inferior face of slab A, aligned with P9. Figure 2 shows the apparatus for displacement reading throughout the tests. These gauges worked as control points which were compared with topographic readings.

Figure 2. Vertical displacement readings in the first floor test.

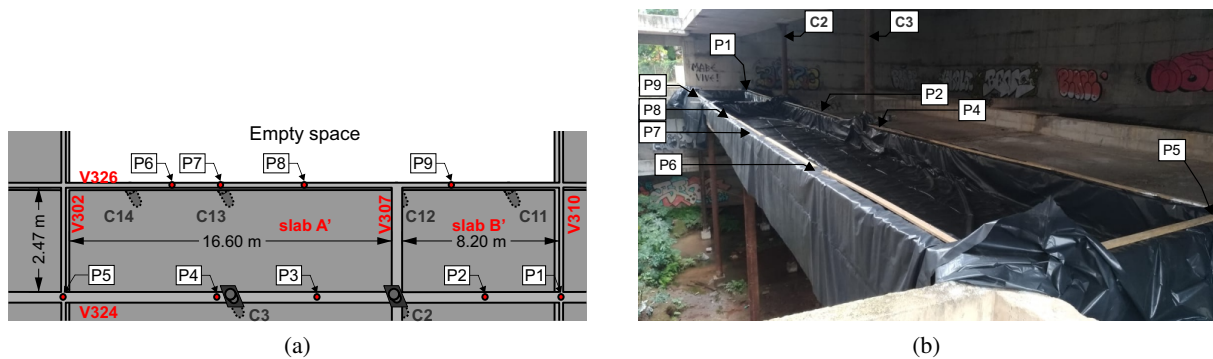
After finishing the first floor load test, the second floor slabs were prepared using equal procedure as the first one. Figure 3 shows the monitoring points employed in this case. However in this case, the loading process was divided into five intervals (load steps), the first three of it were applied on slab A while the last two on slab B. The medium water depth for intervals 1, 2 and 3 on slab A were 18cm, 34cm, 50cm, respectively. When slab A was filled, intervals 4 and 5 were applied in slab B with medium water depths 19cm and 46cm, respectively.

Figure 3. Monitoring points in the second floor slabs.

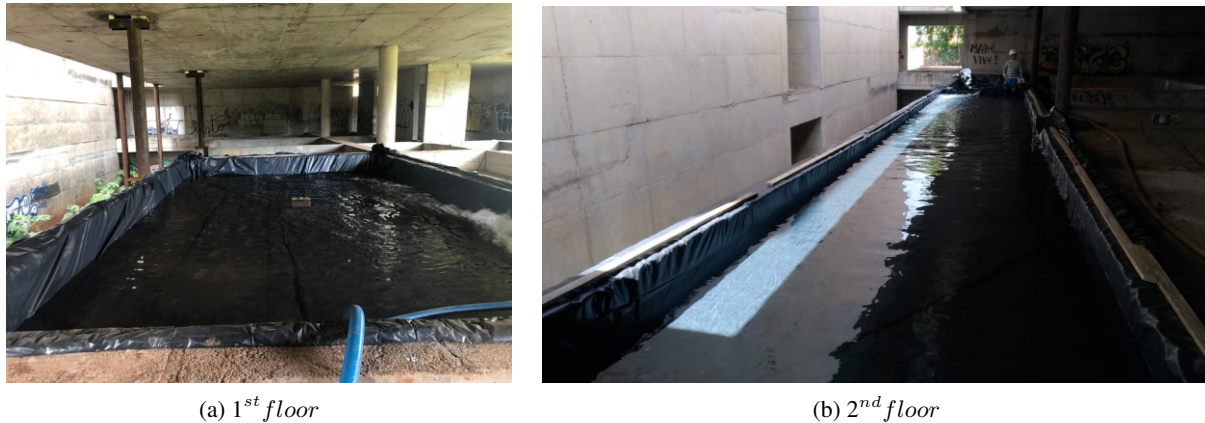
Figure 4 shows the loading procedure. When the water level reached certain depth, it had taken a 5-minute pause before the displacement measurements started. Thus, this was done to avoid possible interferences in the readings due to the water movement.

Figure 4. Loading test of the first and second floor.
